Windstorm Mitigation Report

Heather Hill Apartments No. 1 Condominium

Dunedin, FL

As of 03-19-2025 | FPAT File# MUD2523673

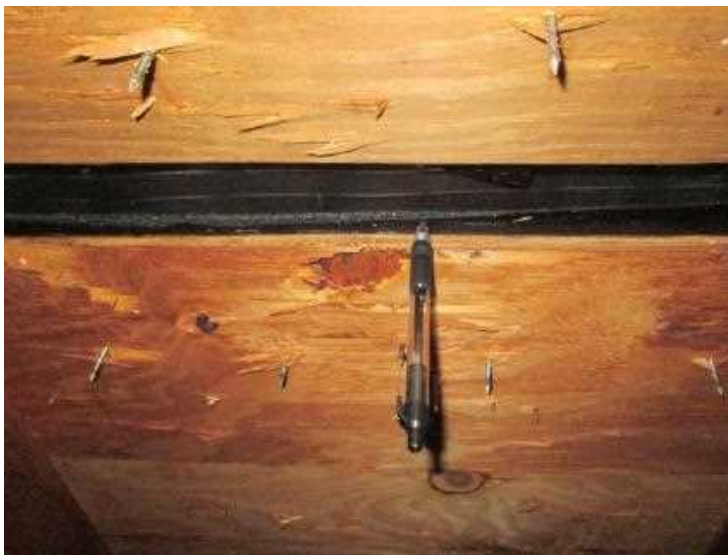
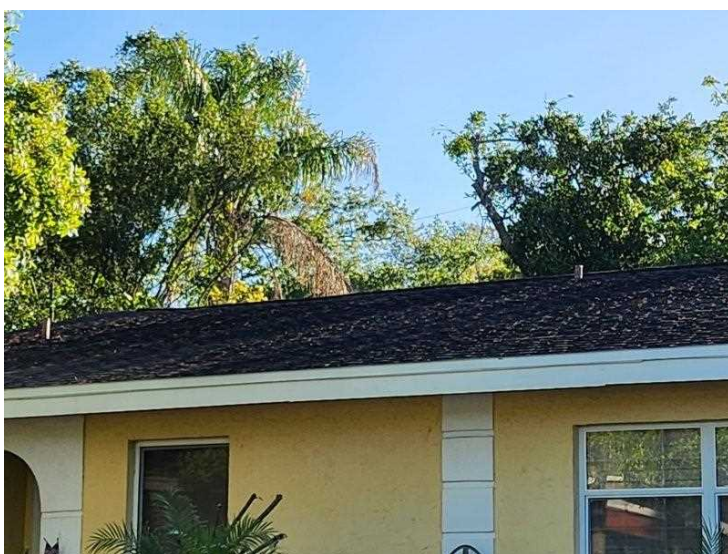
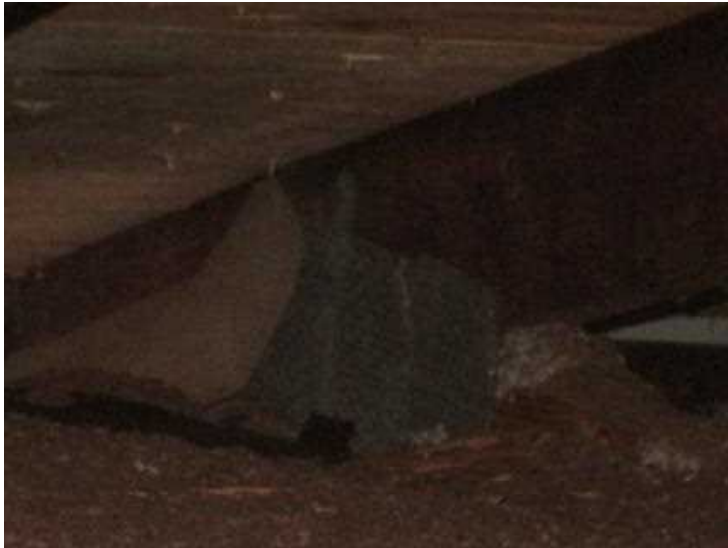
Roof Construction

- 6. SWR:** **Yes**
Comments: SWR was verified at time of inspection. The Secondary Water Resistance verified is a self-adhering peel and stick.
- 7. Opening Protection:** **None or Some Glazed Openings**
Comments: At the time of inspection no opening protection was verified.

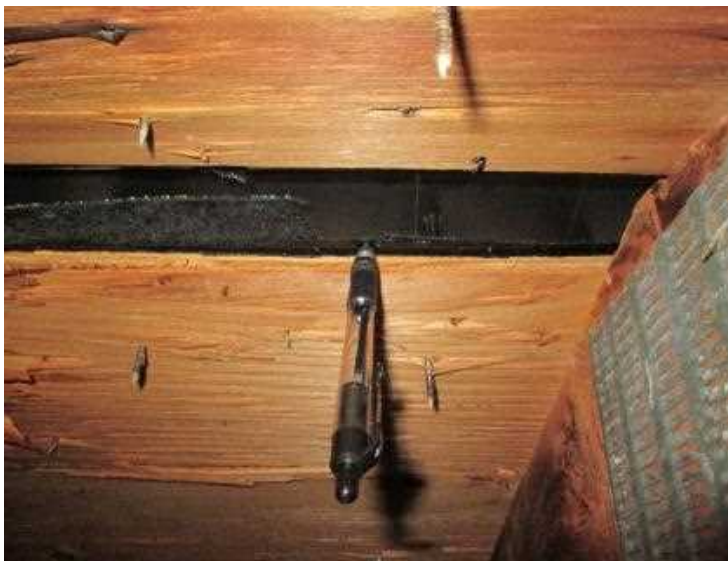
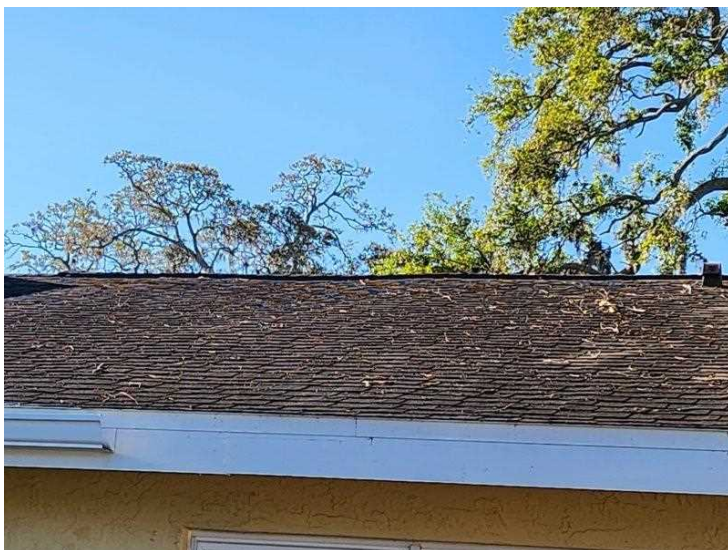
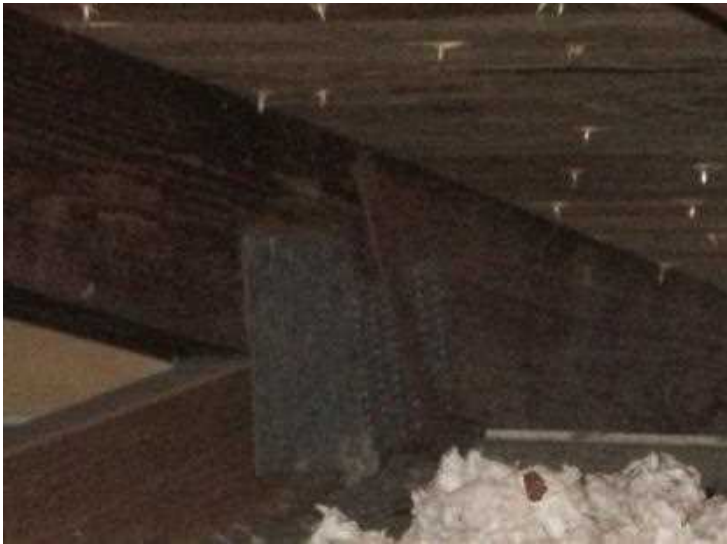
Roof Construction

- 4. Roof to Wall Attachment:** **Toe Nails**
Comments: Inspection verified embedded straps fastened with less than three nails.
- 5. Roof Geometry:** **Other Roof**
Comments: Inspection verified a gable roof shape.

- 6. SWR:** **Yes**
Comments: SWR was verified at time of inspection. The Secondary Water Resistance verified is a self-adhering peel and stick.
- 7. Opening Protection:** **None or Some Glazed Openings**
Comments: At the time of inspection no opening protection was verified.

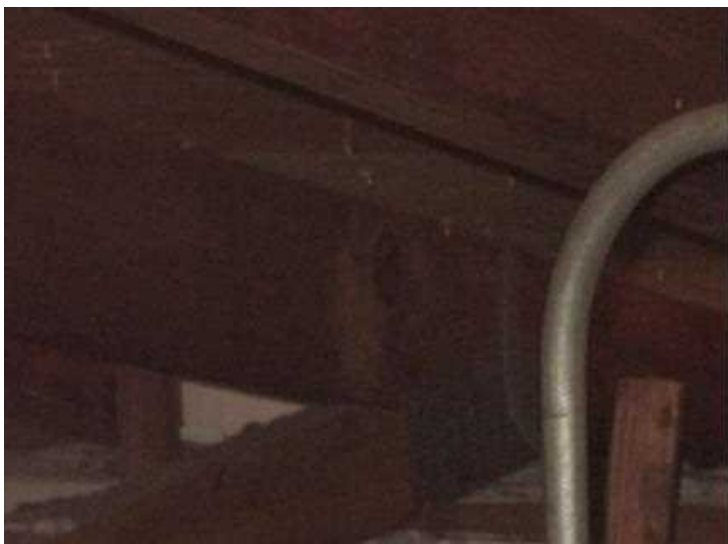
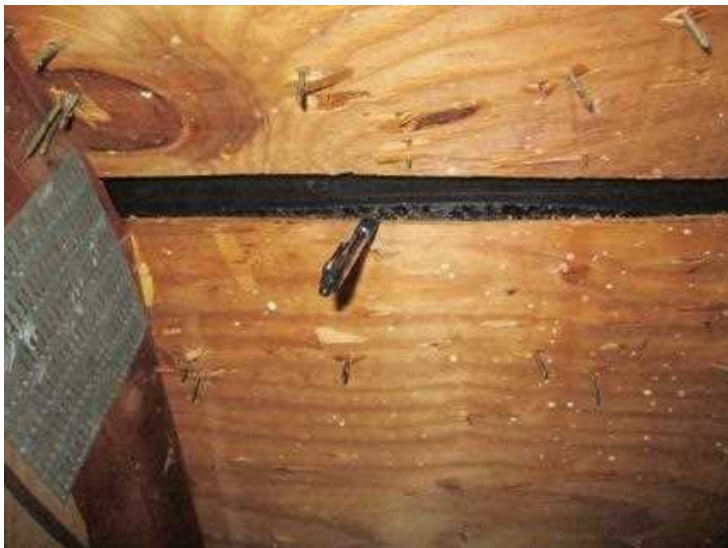
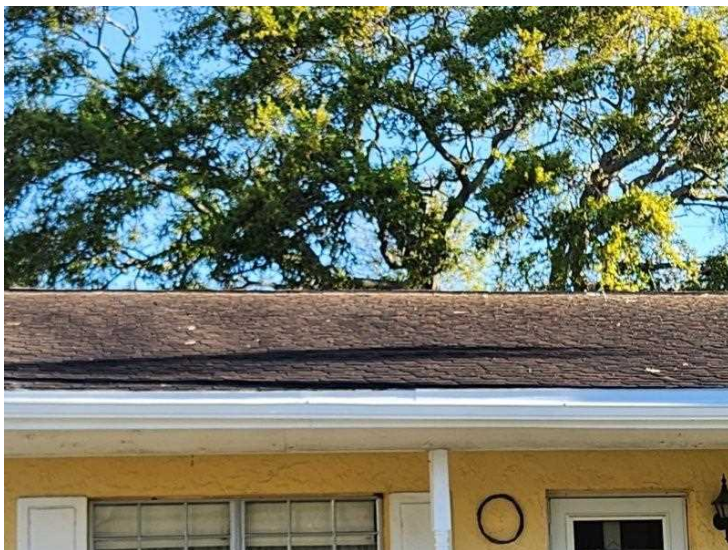
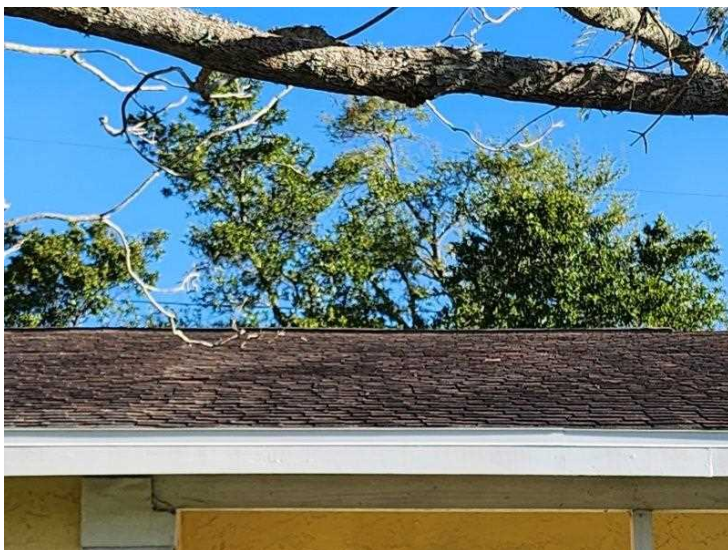
Roof Construction

- 4. Roof to Wall Attachment:** **Toe Nails**
Comments: Inspection verified embedded straps fastened with less than three nails.
- 5. Roof Geometry:** **Other Roof**
Comments: Inspection verified a gable roof shape.

- 6. SWR:** **Yes**
Comments: SWR was verified at time of inspection. The Secondary Water Resistance verified is a self-adhering peel and stick.
- 7. Opening Protection:** **None or Some Glazed Openings**
Comments: At the time of inspection no opening protection was verified.

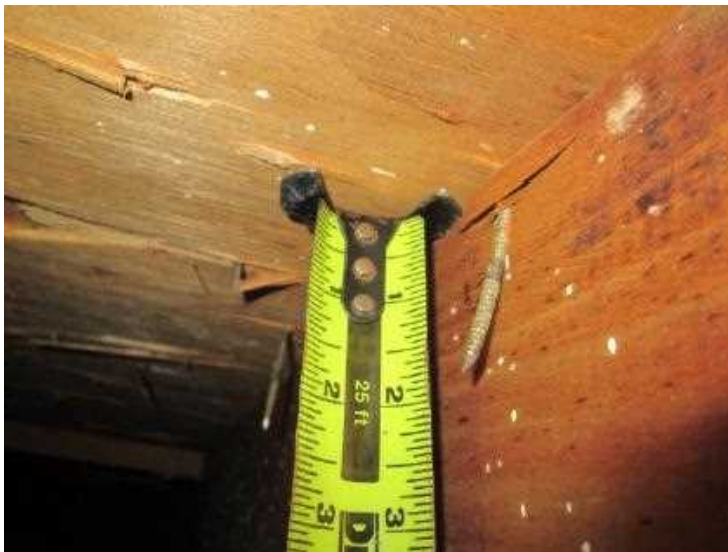
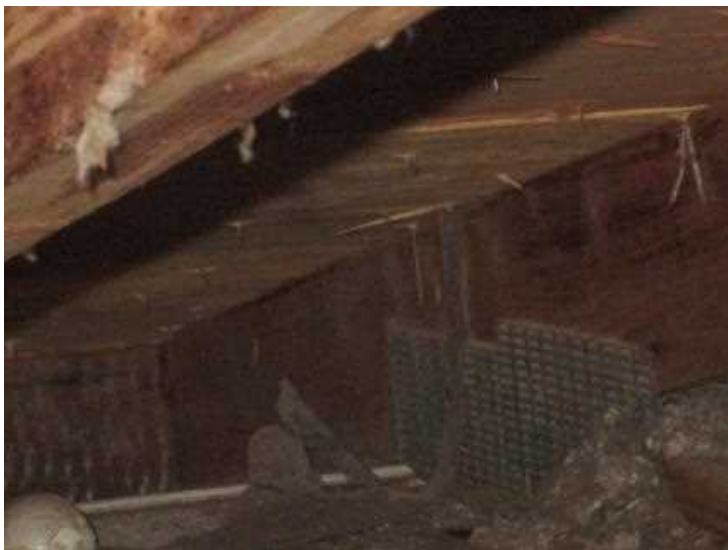
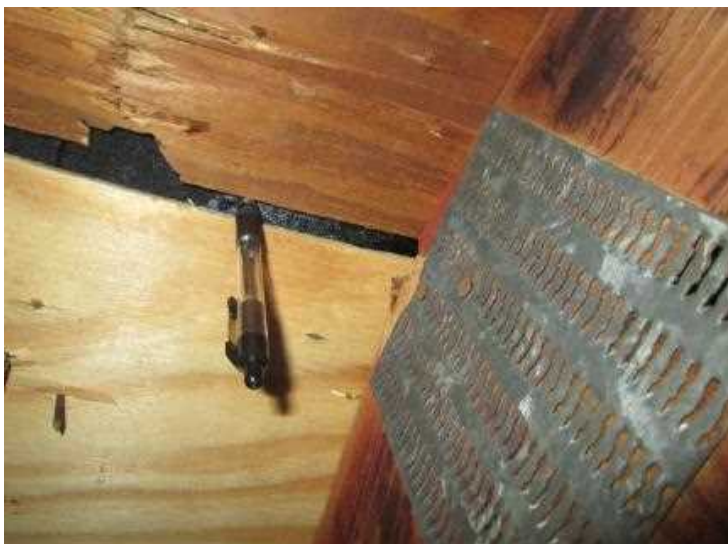
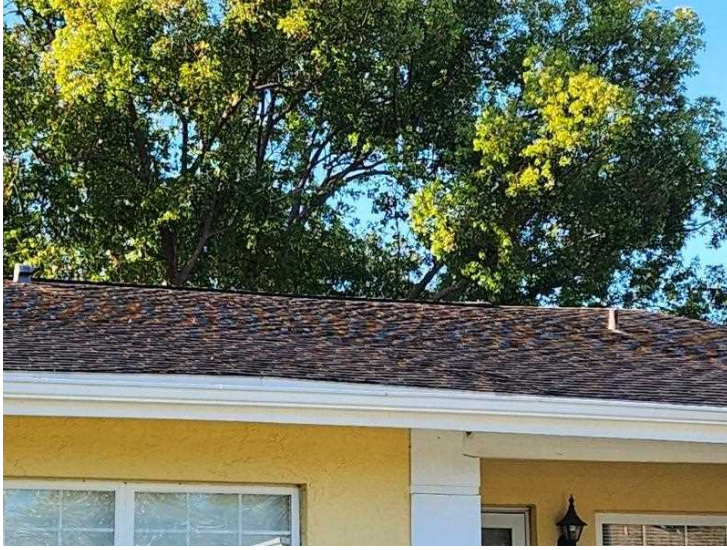
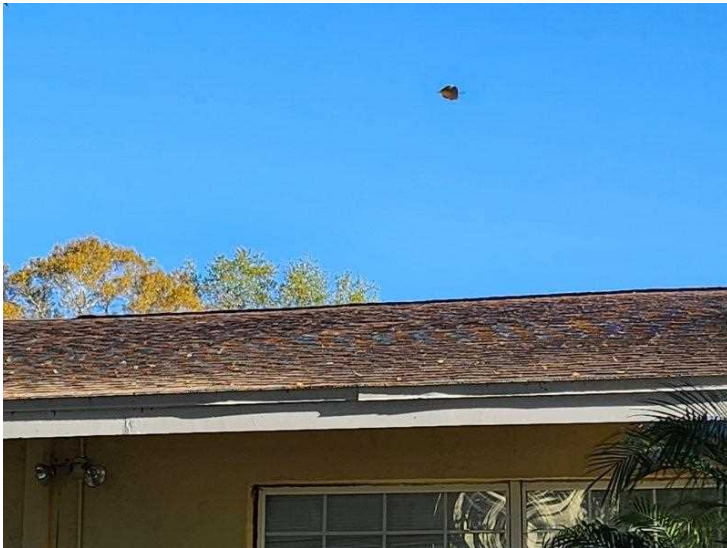
Roof Construction

- 4. Roof to Wall Attachment:** **Toe Nails**
Comments: Inspection verified embedded straps fastened with less than three nails.
- 5. Roof Geometry:** **Other Roof**
Comments: Inspection verified a gable roof shape.

- 6. SWR:** **Yes**
Comments: SWR was verified at time of inspection. The Secondary Water Resistance verified is a self-adhering peel and stick.
- 7. Opening Protection:** **None or Some Glazed Openings**
Comments: At the time of inspection no opening protection was verified.

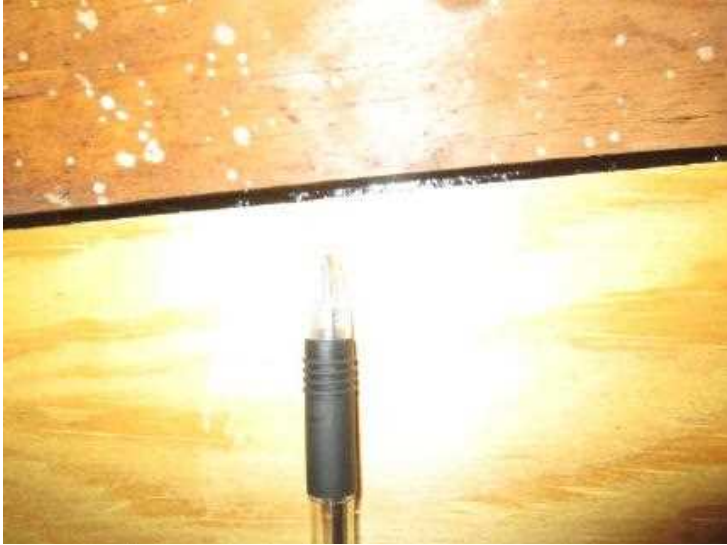
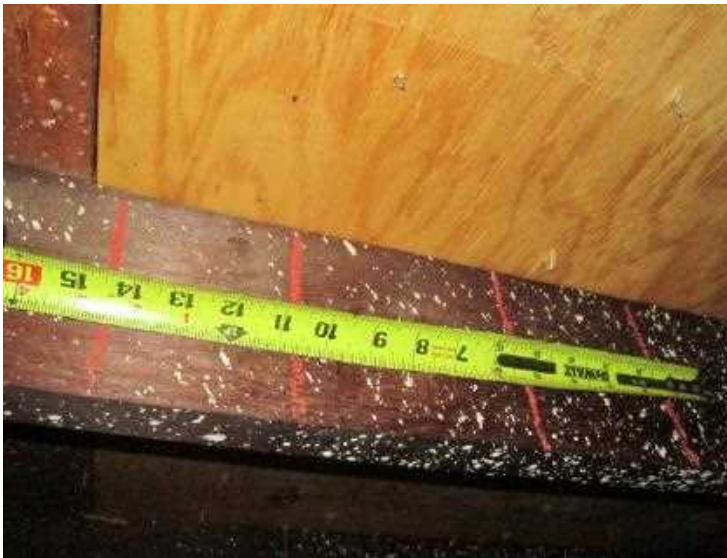
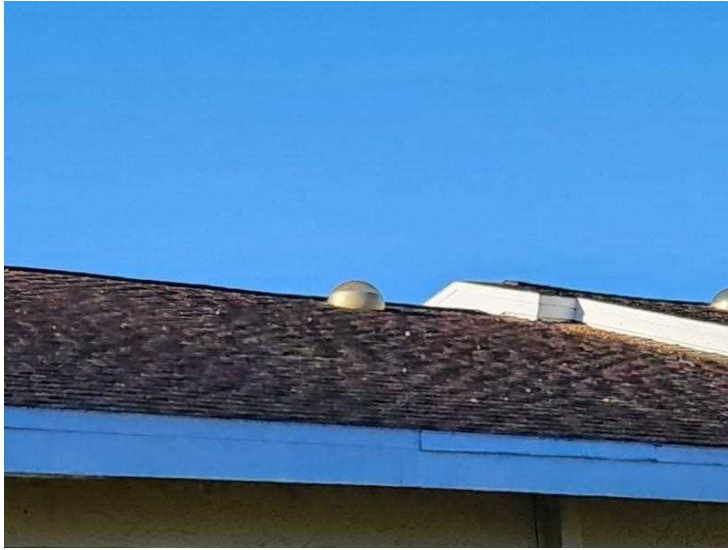
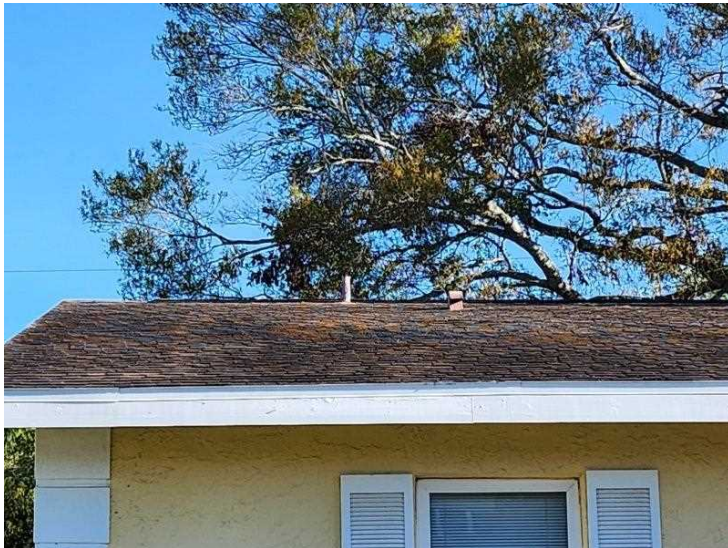
Roof Construction

- 6. SWR:** **Yes**
Comments: SWR was verified at time of inspection. The Secondary Water Resistance verified is a self-adhering peel and stick.
- 7. Opening Protection:** **None or Some Glazed Openings**
Comments: At the time of inspection no opening protection was verified.

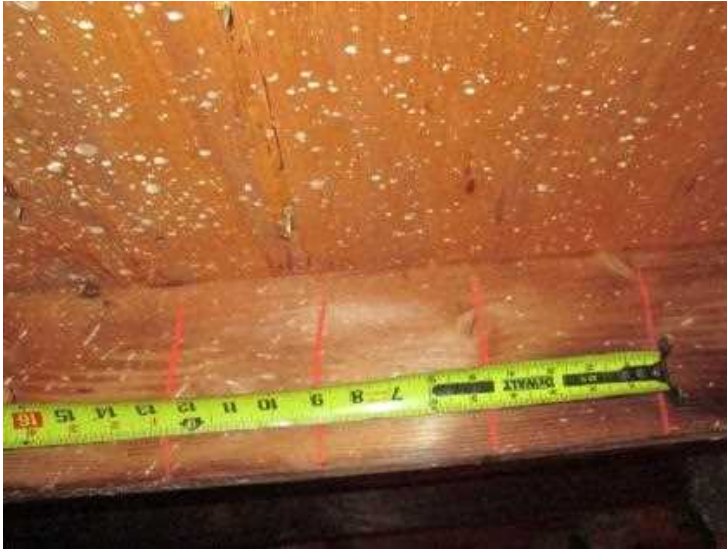
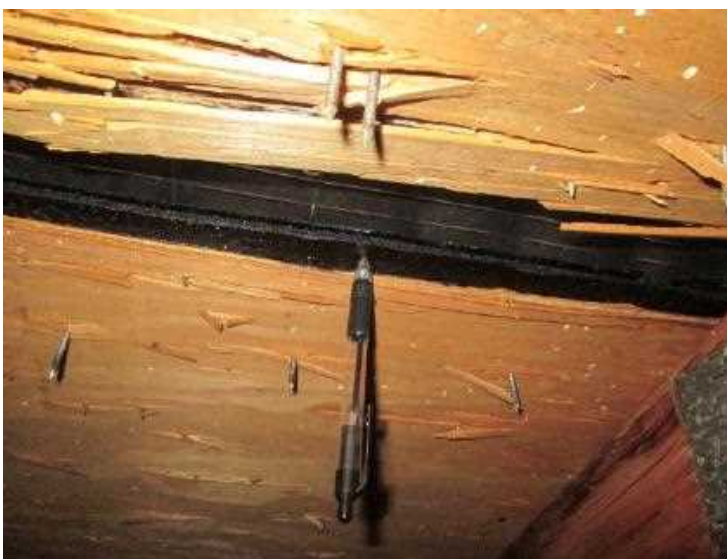
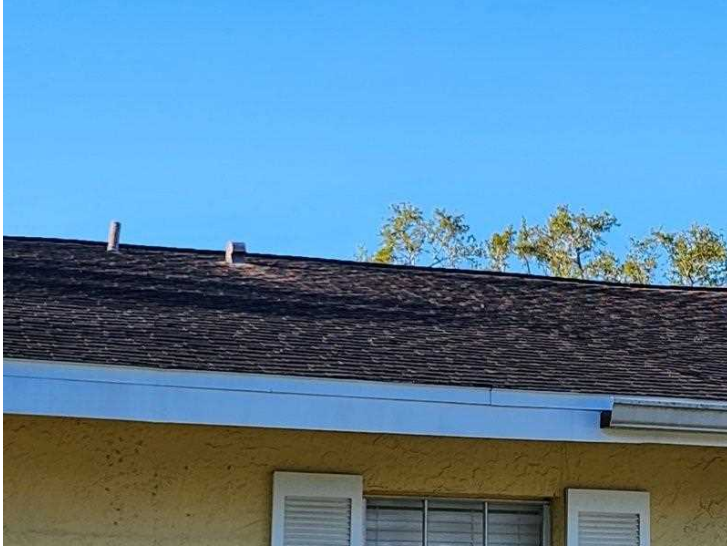
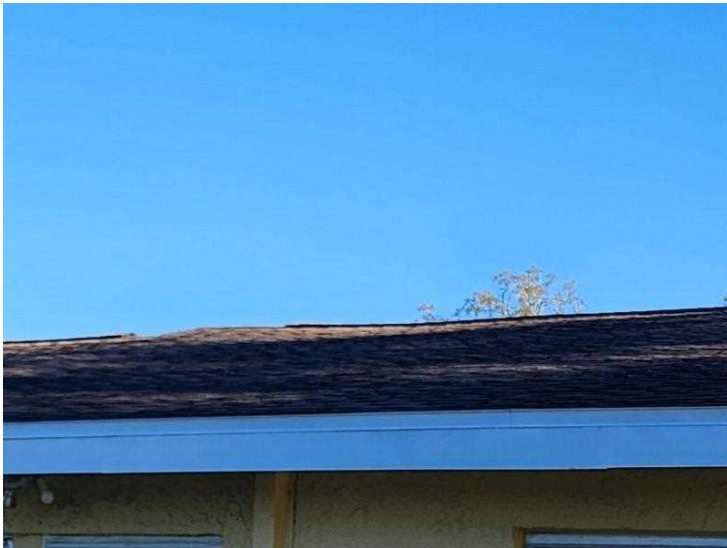
Roof Construction

- 6. SWR:** **Yes**
Comments: SWR was verified at time of inspection. The Secondary Water Resistance verified is a self-adhering peel and stick.
- 7. Opening Protection:** **None or Some Glazed Openings**
Comments: At the time of inspection no opening protection was verified.

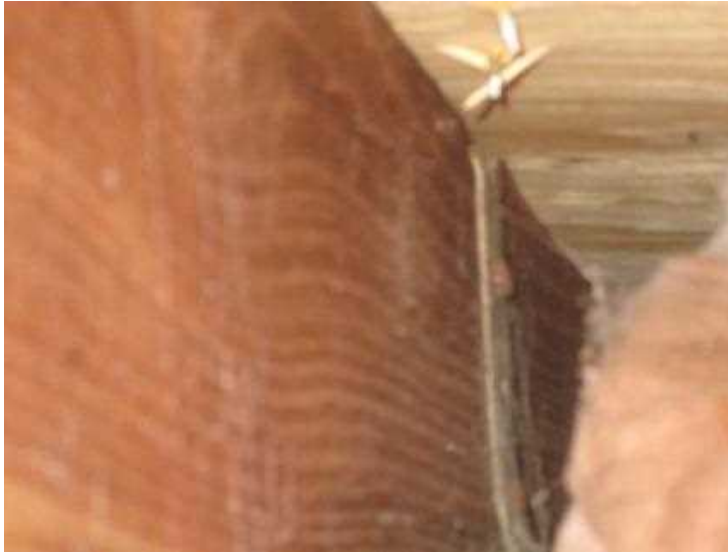
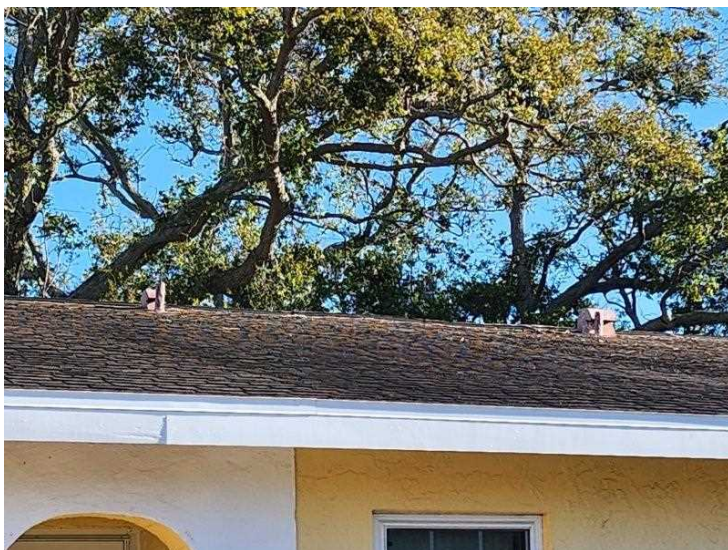
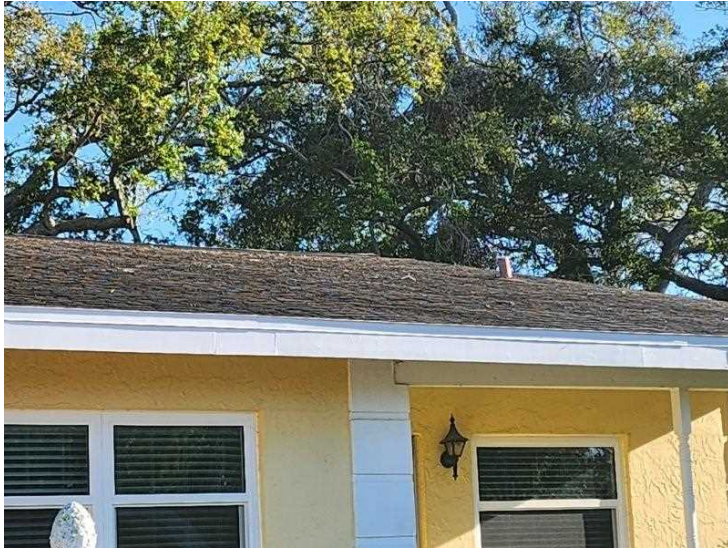
Roof Construction

- 6. SWR:** **Yes**
Comments: SWR was verified at time of inspection. The Secondary Water Resistance verified is a self-adhering peel and stick.
- 7. Opening Protection:** **None or Some Glazed Openings**
Comments: At the time of inspection no opening protection was verified.
