## COMMERCIAL WINDSTORM MITIGATION REPORT

Heather Hill Apartments No. 1 Condominium Association, Inc.

As of 1/3/2020

FPAT File# MUD1913903

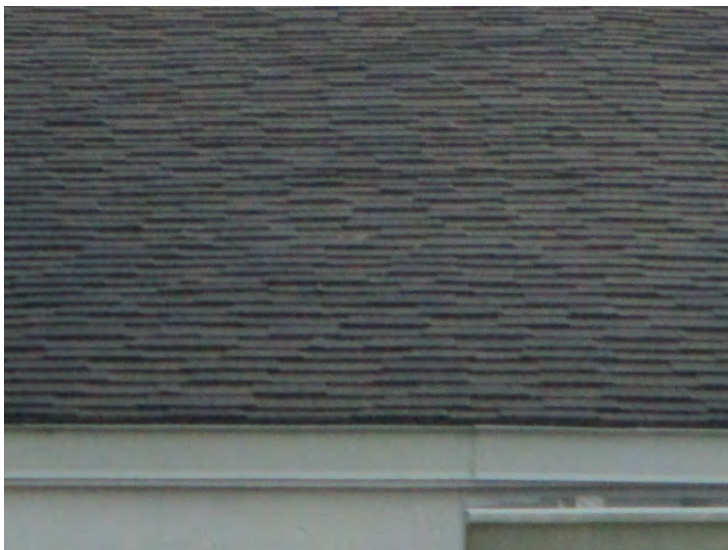
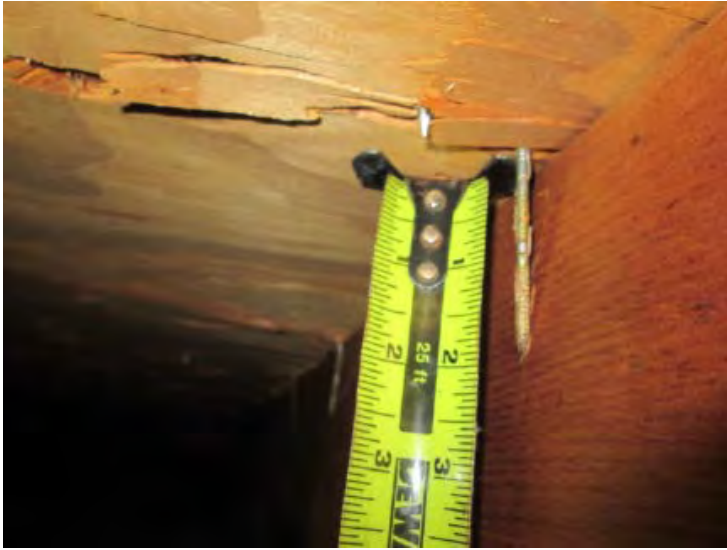
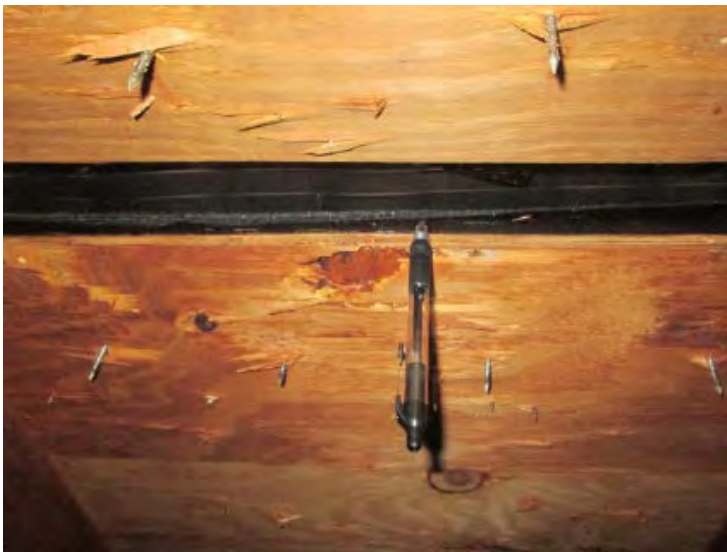
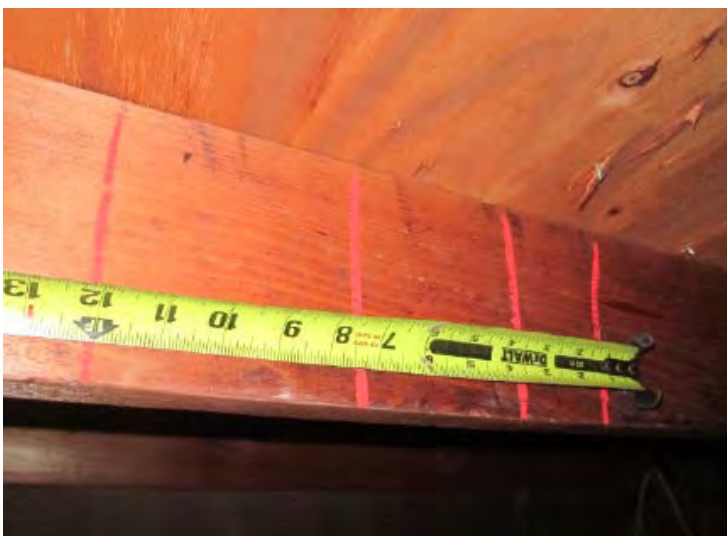
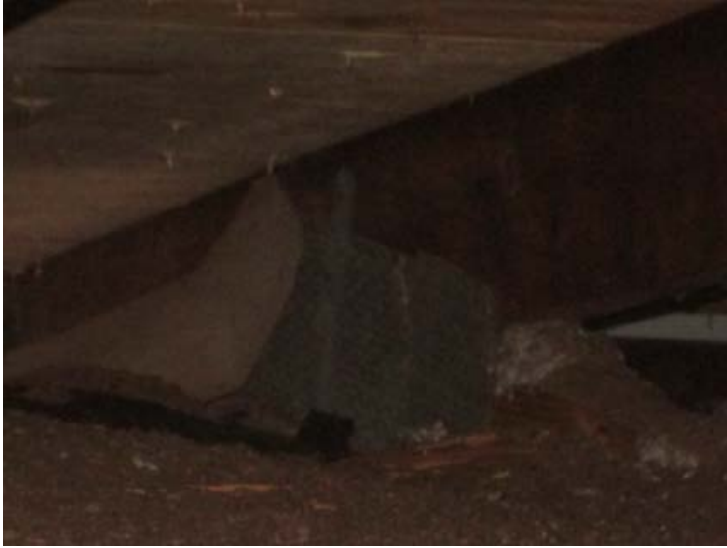
Roof Construction

| <b>2. <u>Roof Covering:</u></b><br>Comments: | <b>FBC Equivalent</b><br>The roof covering was replaced in 2014. The roof permit was confirmed and the permit number is 14-898. This roof was verified as meeting the building code requirements outlined on the mitigation affidavit. |
| <b>6. <u>SWR:</u></b><br>Comments: | <b>Yes</b><br>SWR was verified at time of inspection. The Secondary Water Resistance verified is a self-adhering peel and stick. |

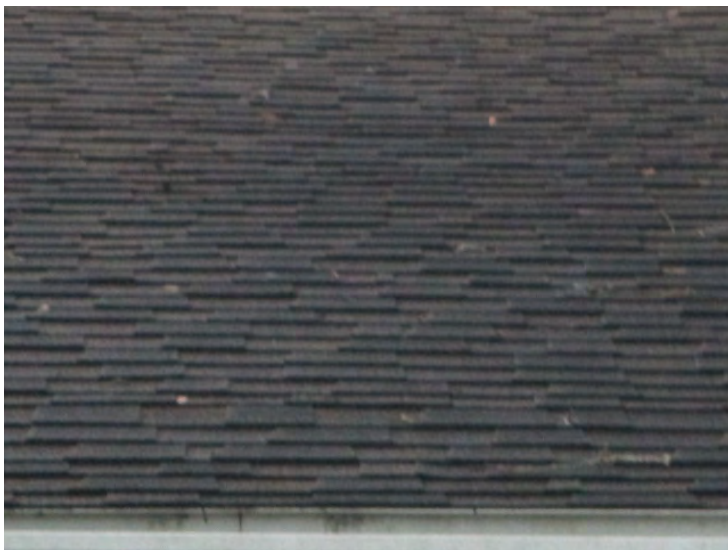
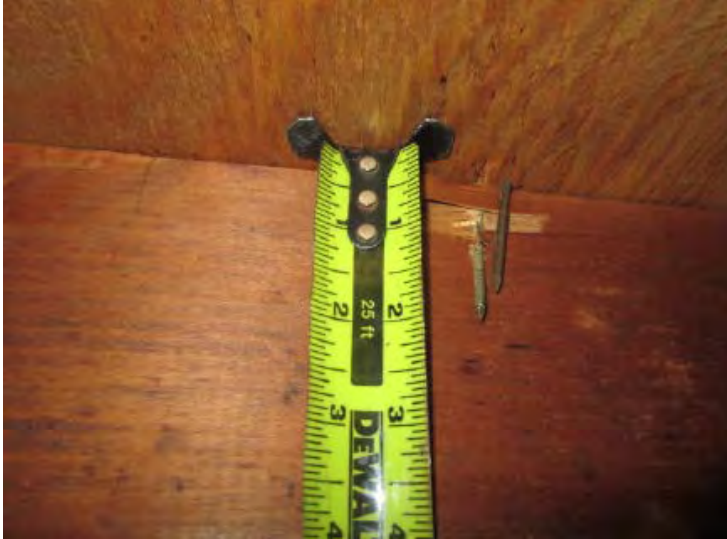
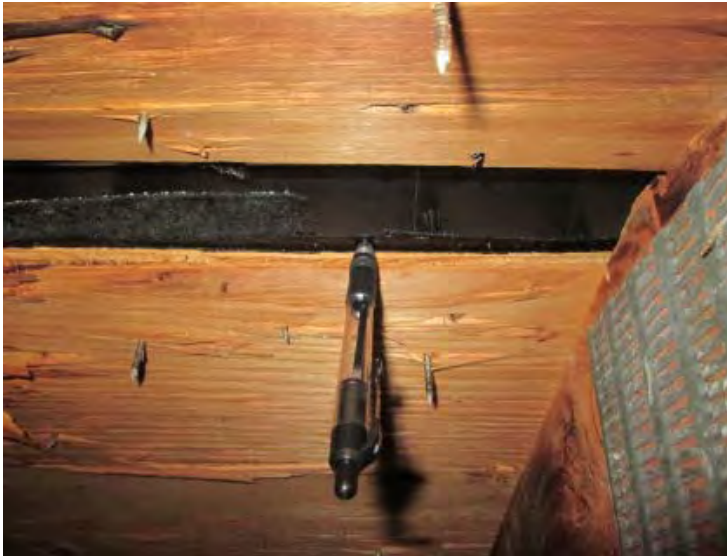
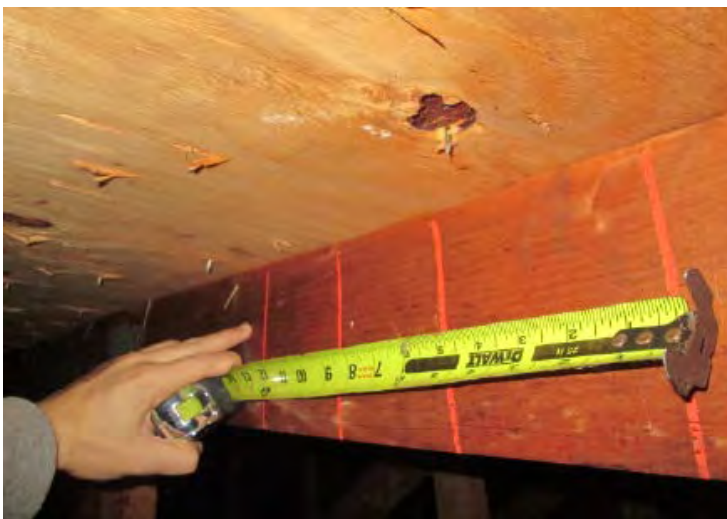
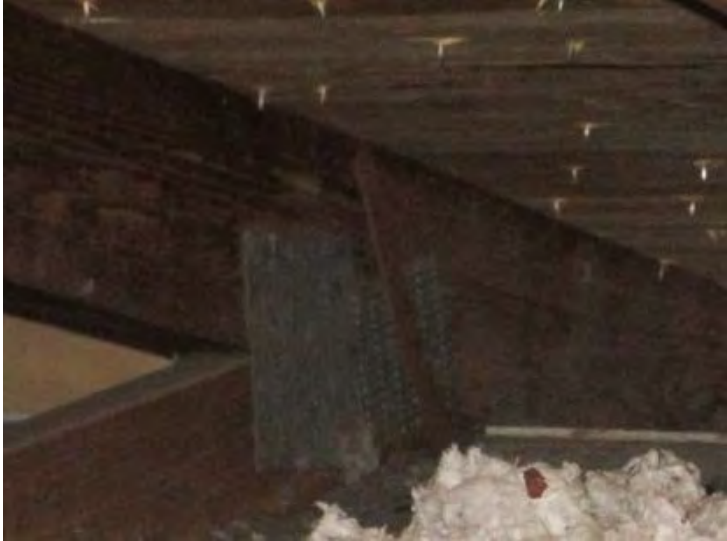
Roof Construction

| <b>2. <u>Roof Covering:</u></b><br>Comments: | <b>FBC Equivalent</b><br>The roof covering was replaced in 2014. The roof permit was confirmed and the permit number is 14-1152. This roof was verified as meeting the building code requirements outlined on the mitigation affidavit. |
| <b>6. <u>SWR:</u></b><br>Comments: | <b>Yes</b><br>SWR was verified at time of inspection. The Secondary Water Resistance verified is a self-adhering peel and stick. |

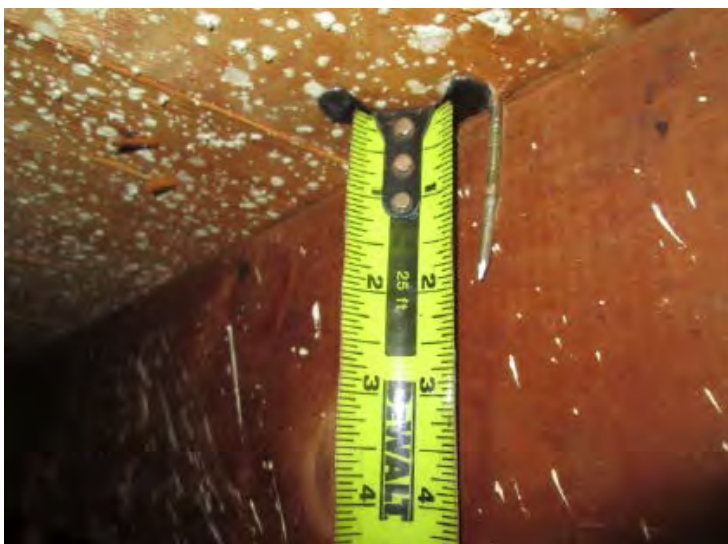
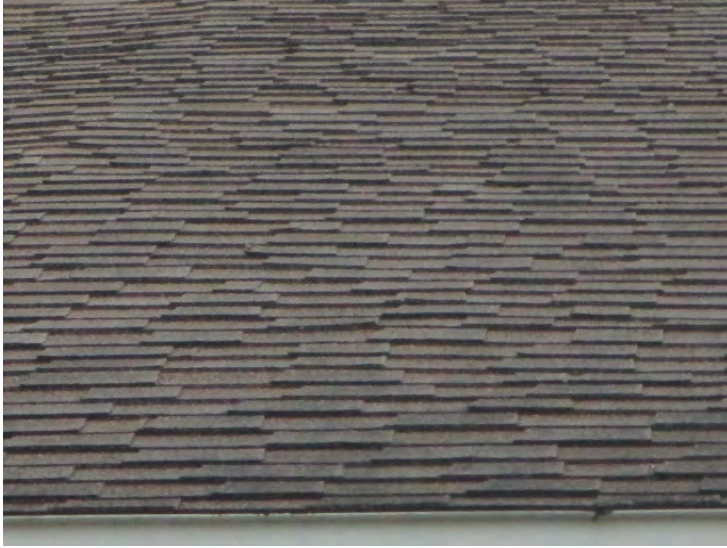
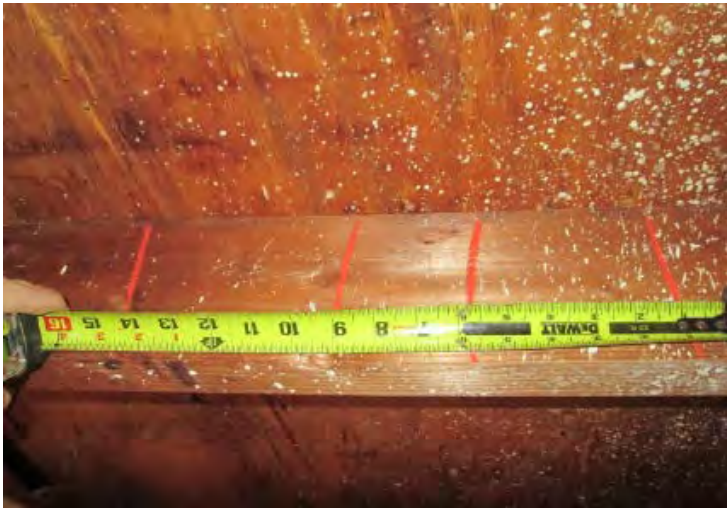
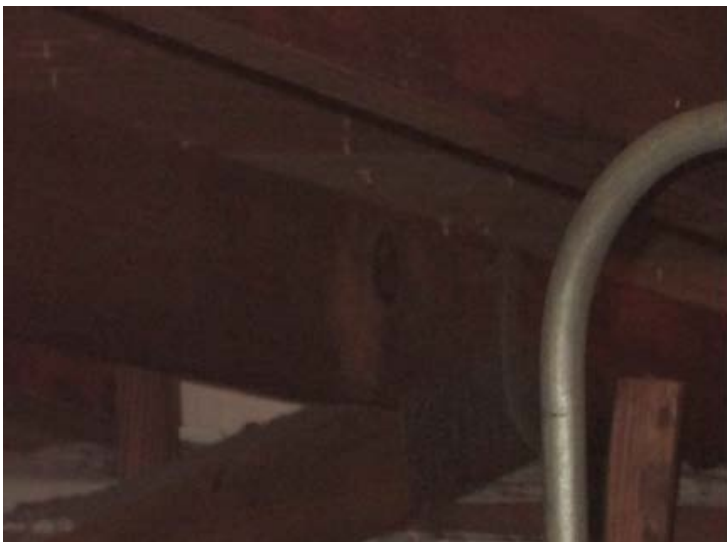
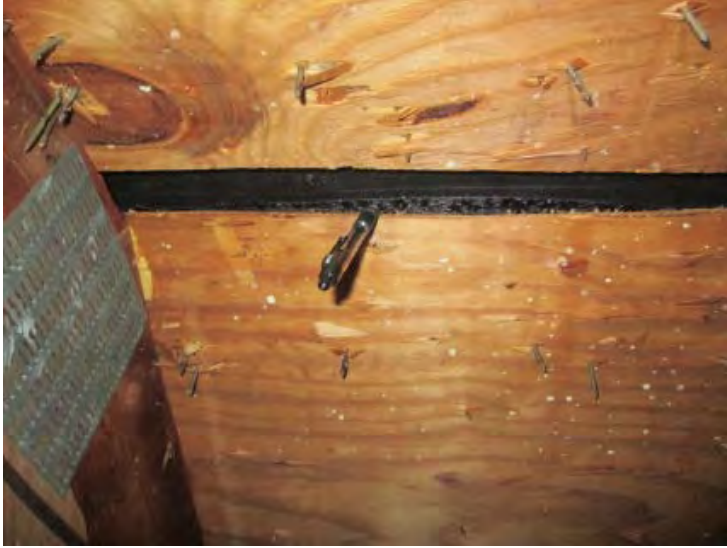
Roof Construction

| <b>2. <u>Roof Covering:</u></b><br>Comments: | <b>FBC Equivalent</b><br>The roof covering was replaced in 2014. The roof permit was confirmed and the permit number is 14-899. This roof was verified as meeting the building code requirements outlined on the mitigation affidavit. |
| <b>6. <u>SWR:</u></b><br>Comments: | <b>Yes</b><br>SWR was verified at time of inspection. The Secondary Water Resistance verified is a self-adhering peel and stick. |

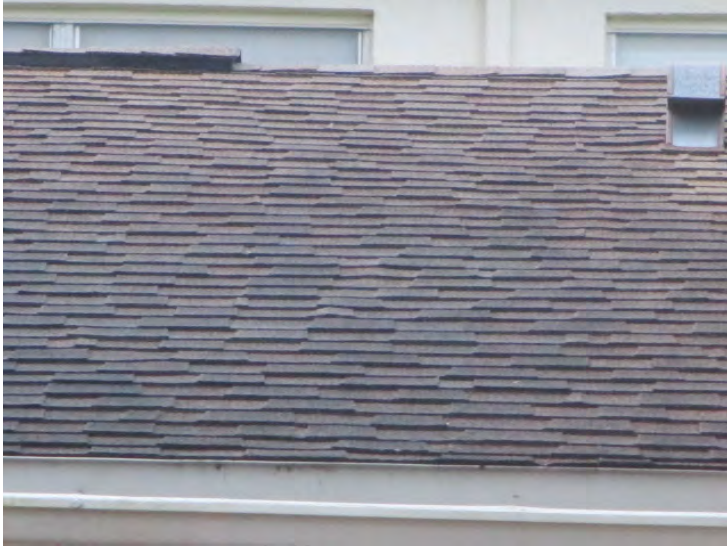
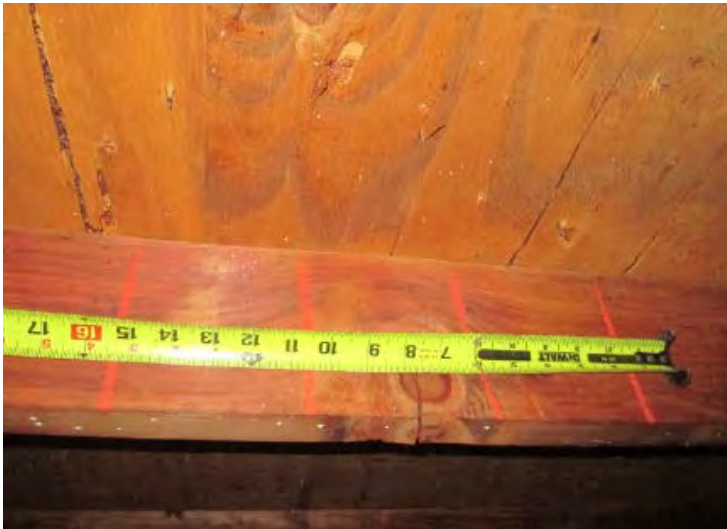
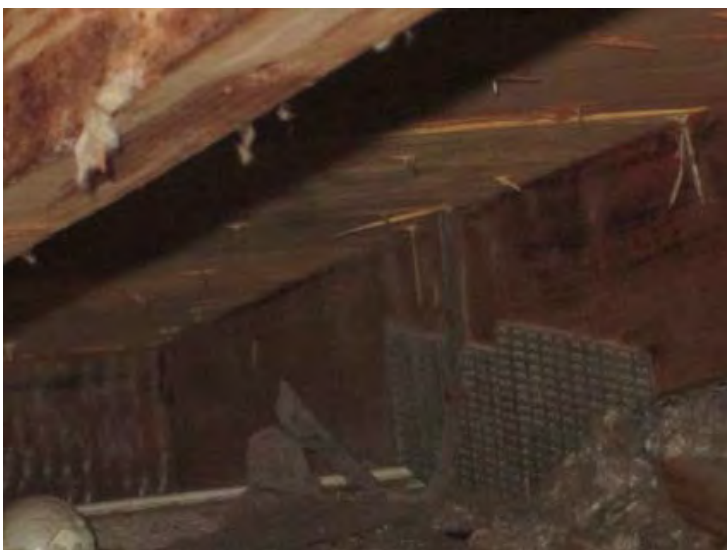
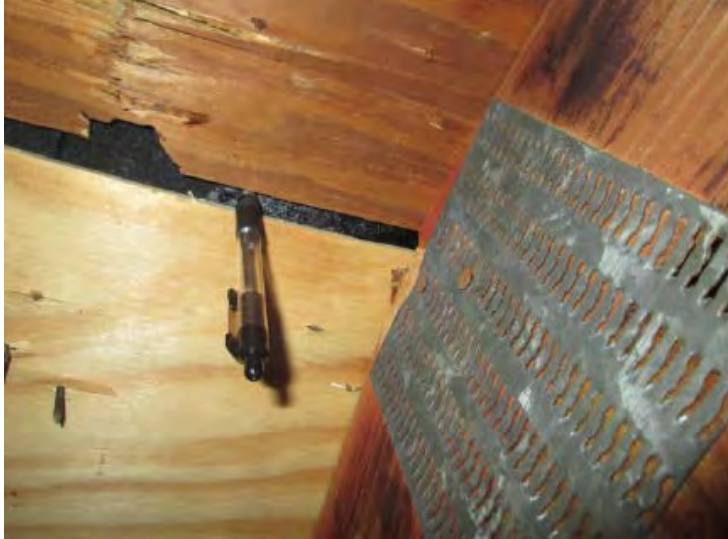
Roof Construction

| <b>2. <u>Roof Covering:</u></b><br>Comments: | <b>FBC Equivalent</b><br>The roof covering was replaced in 2014. The roof permit was confirmed and the permit number is 14-795. This roof was verified as meeting the building code requirements outlined on the mitigation affidavit. |
| <b>6. <u>SWR:</u></b><br>Comments: | <b>Yes</b><br>SWR was verified at time of inspection. The Secondary Water Resistance verified is a self-adhering peel and stick. |

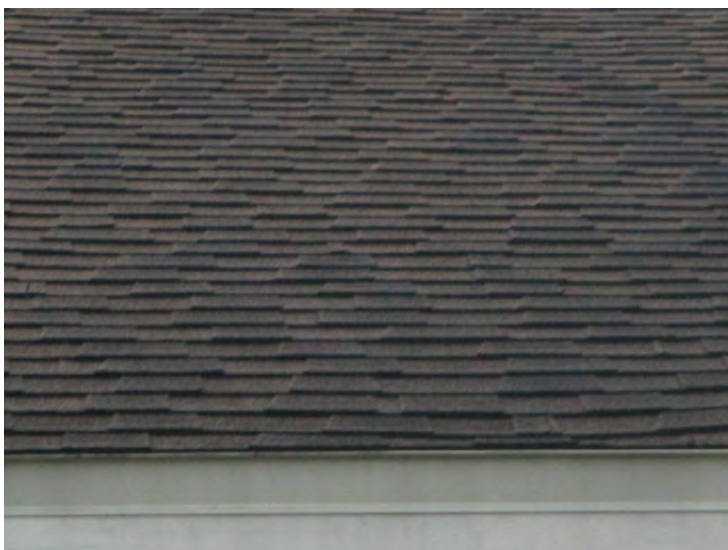
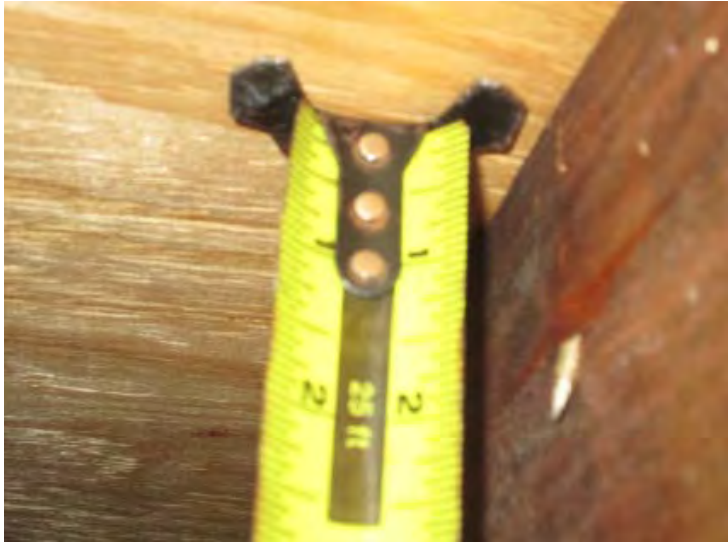
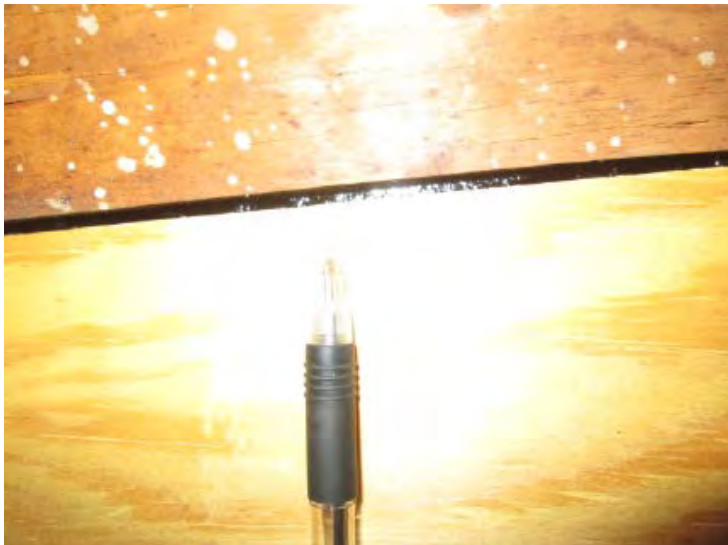
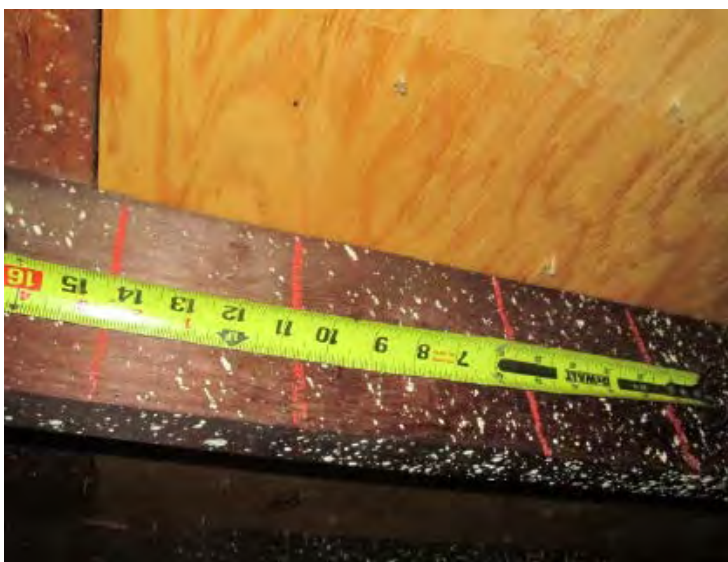
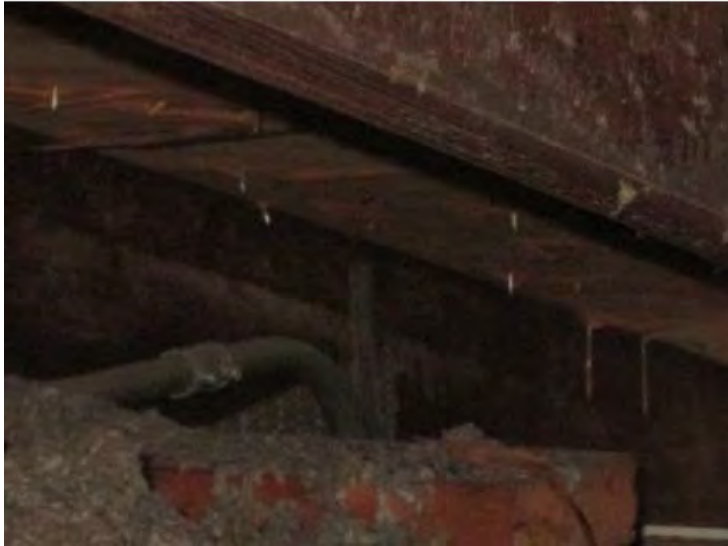
Roof Construction

| <b>2. <u>Roof Covering:</u></b><br>Comments: | <b>FBC Equivalent</b><br>The roof covering was replaced in 2014. The roof permit was confirmed and the permit number is 14-1151. This roof was verified as meeting the building code requirements outlined on the mitigation affidavit. |
| <b>6. <u>SWR:</u></b><br>Comments: | <b>Yes</b><br>SWR was verified at time of inspection. The Secondary Water Resistance verified is a self-adhering peel and stick. |

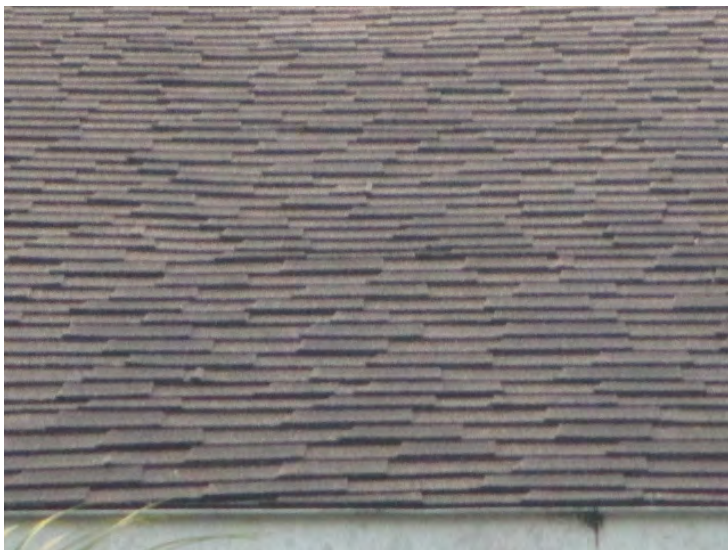
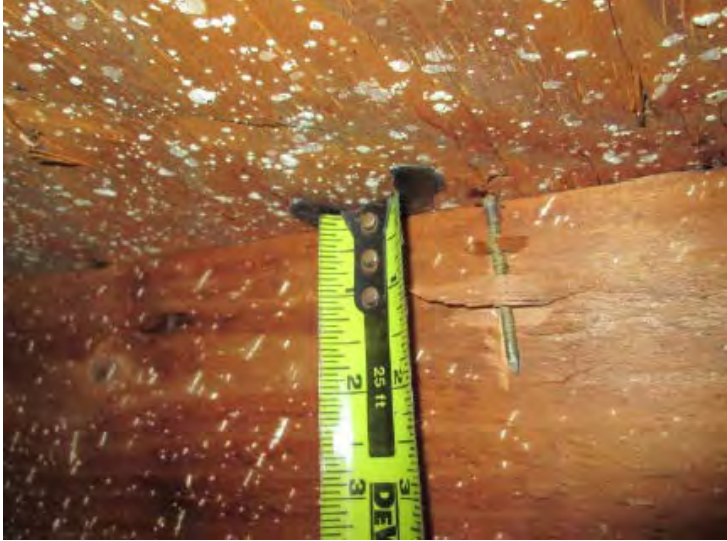
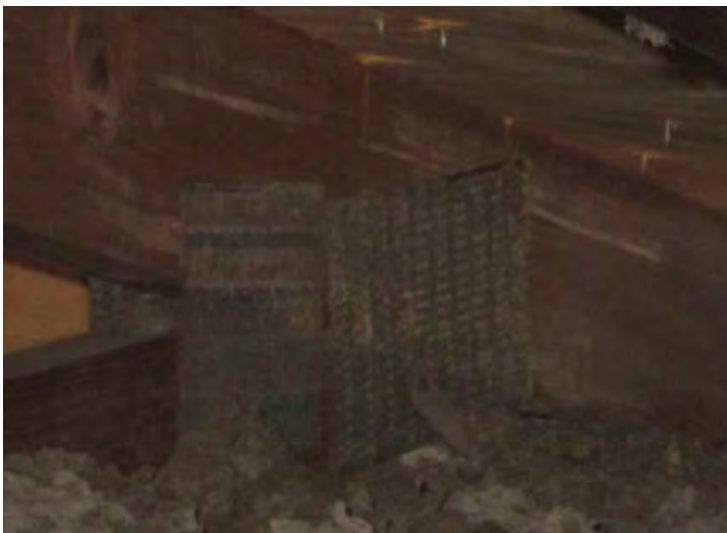
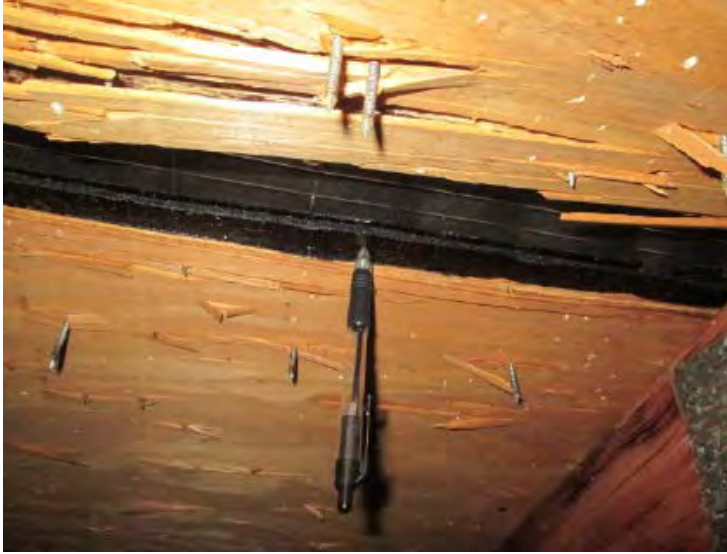
Roof Construction

| <b>2. <u>Roof Covering:</u></b><br>Comments: | <b>FBC Equivalent</b><br>The roof covering was replaced in 2014. The roof permit was confirmed and the permit number is 14-1001. This roof was verified as meeting the building code requirements outlined on the mitigation affidavit. |
| <b>6. <u>SWR:</u></b><br>Comments: | <b>Yes</b><br>SWR was verified at time of inspection. The Secondary Water Resistance verified is a self-adhering peel and stick. |

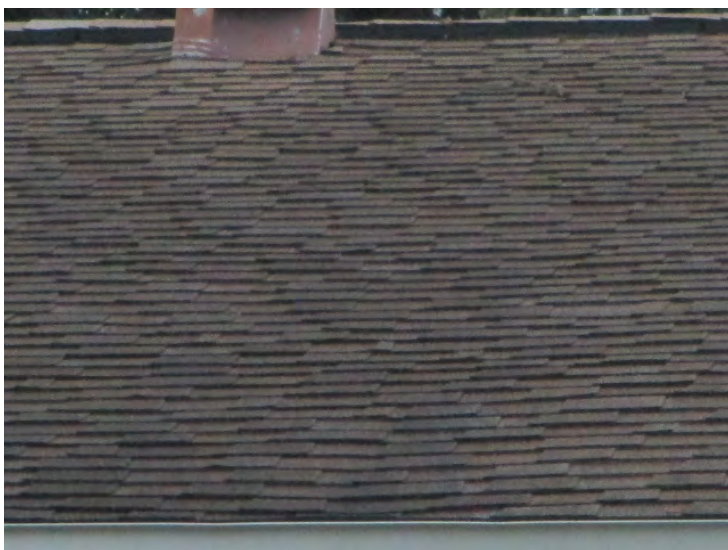
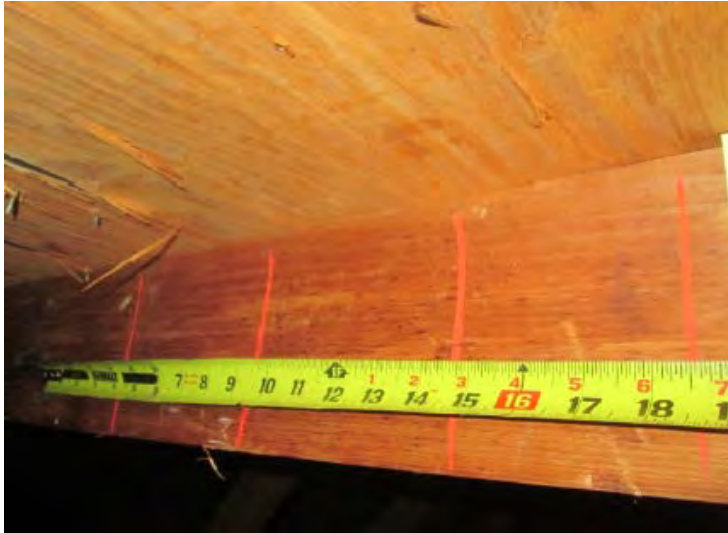
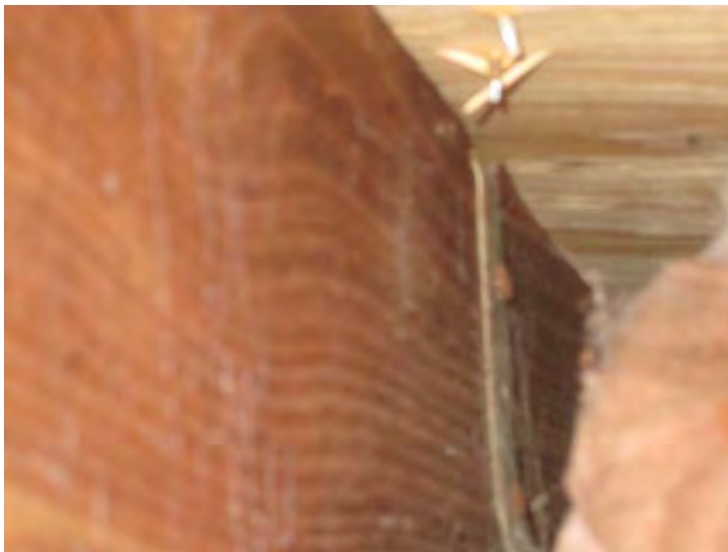
Roof Construction

| <b>2. <u>Roof Covering:</u></b><br>Comments: | <b>FBC Equivalent</b><br>The roof covering was replaced in 2014. The roof permit was confirmed and the permit number is 14-1002. This roof was verified as meeting the building code requirements outlined on the mitigation affidavit. |
| <b>6. <u>SWR:</u></b><br>Comments: | <b>Yes</b><br>SWR was verified at time of inspection. The Secondary Water Resistance verified is a self-adhering peel and stick. |
